Manhole Inspection Summary

Manhole # S27CC_010MH

Location Address: **1419 MYRTLE AVE**

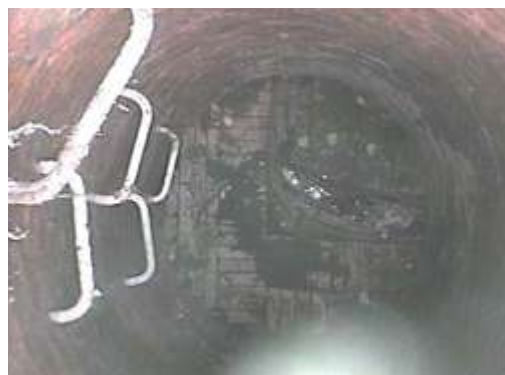
Defect 1

Steps Count: **6** Missing: **0** ☒ **Corroded**

CORRODED STEPS

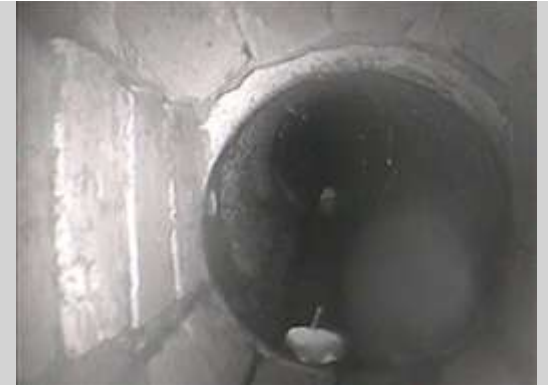
12 O'Clock Outflow

8 in. Circular Gravity Sewer
Pipe Out @ 12 O'Clock

Pipe Material: **Clay** ☐ Pipe Lined

Invert Depth: **9.90** (ft.) Flow Characteristics: **Slow**

Deposits: ☒ None ☐ Mud ☐ Sludge ☐ Debris ☐ Grease

Infiltration: **None** Pipe Seal Cond: **Sound**

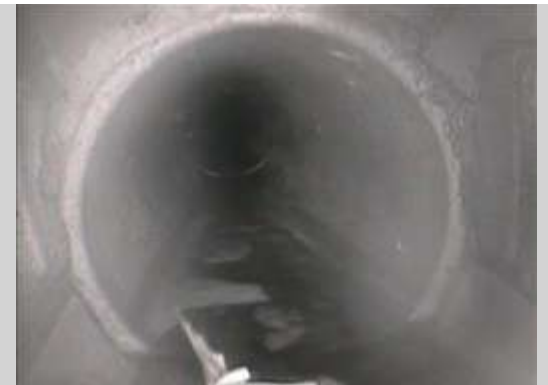
3 O'Clock Inflow

8 in. Circular Gravity Sewer
Pipe In @ 3 O'Clock

Pipe Material: **Clay** ☐ Pipe Lined

Invert Depth: **9.70** (ft.) Flow Characteristics: **Slow**

Deposits: ☒ None ☐ Mud ☐ Sludge ☐ Debris ☐ Grease

Infiltration: **None** Pipe Seal Cond: **Sound**
